## Museum of Making, Silk Mill, Derby

Derby Silk Mill Industrial Museum (a Grade II listed building) was remodelled as the Museum of Making. This £17m project (grant funded by the HLF) involved the repair of the existing building, verification of its load capacity and construction of a new Atrium adjacent to the existing building.

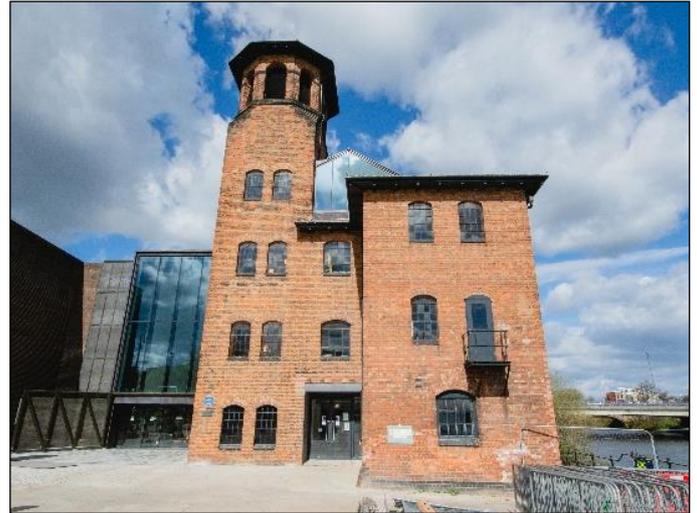
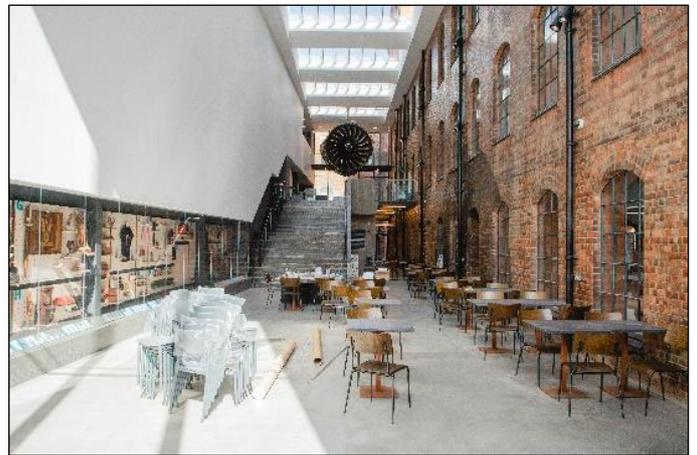
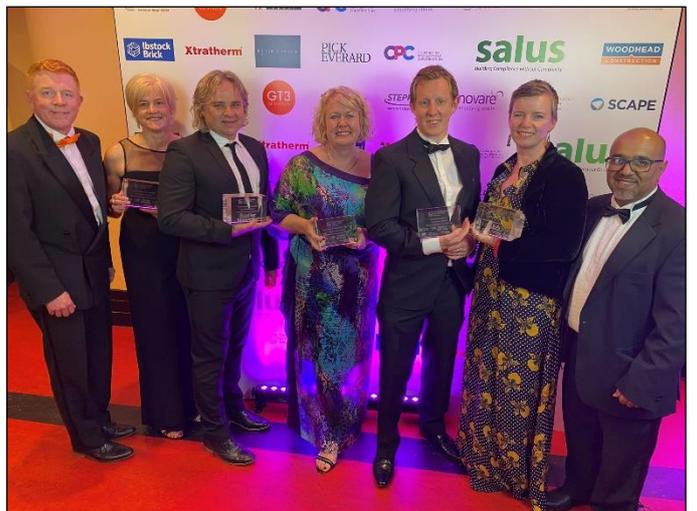
Our designs were constantly conscious of the visual impact of the existing structure. In the design of the Atrium steelwork, we installed a new truss within the existing building floor which enabled wind loads on the Atrium to be transferred to the existing building, avoiding the use of heavy cantilevered columns (and the high carbon cost of the associated substructure) or a portalised frame which would have disrupted the rhythm of the existing listed building façade.

Our attention to aesthetic sense and detail retained large elements of structure on show, for example the new wind truss to the second floor was left uncovered by the Architect once installed as an exemplar within the Museum of real world 'Making'.

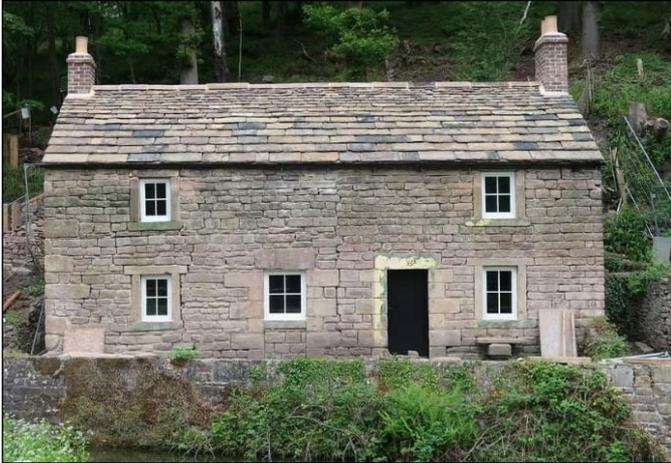
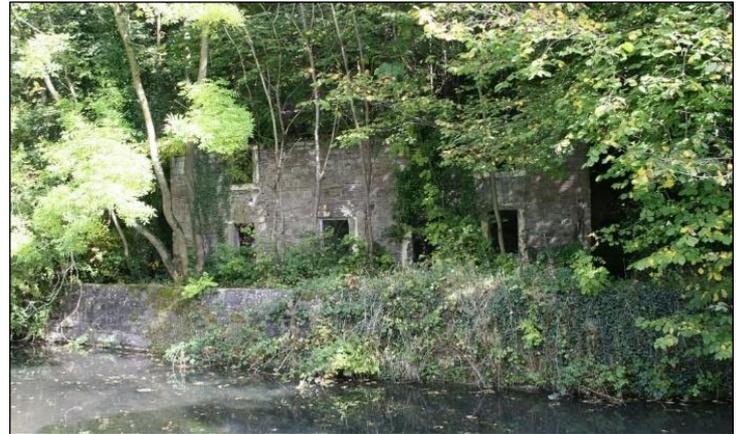
The repairs included the structural design of a new timber truss and purlins to allow for replacement of the roof structure as part of the restoration to the Grade II listed building.

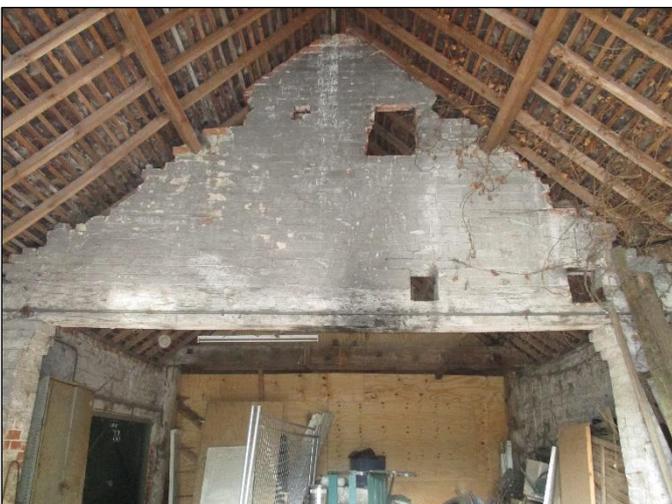
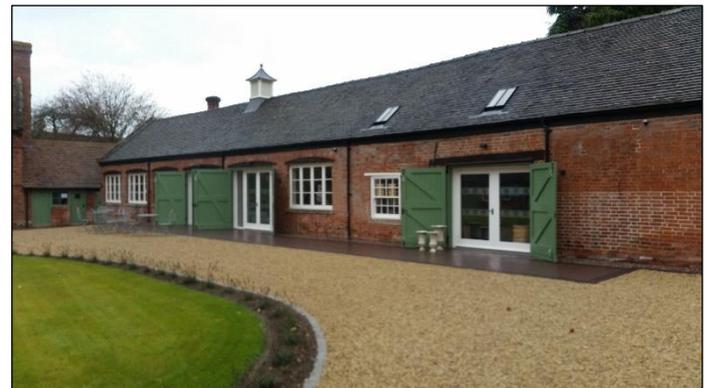
These were in a dilapidated condition with extensive rot of timber roof structures and instability of masonry walls.

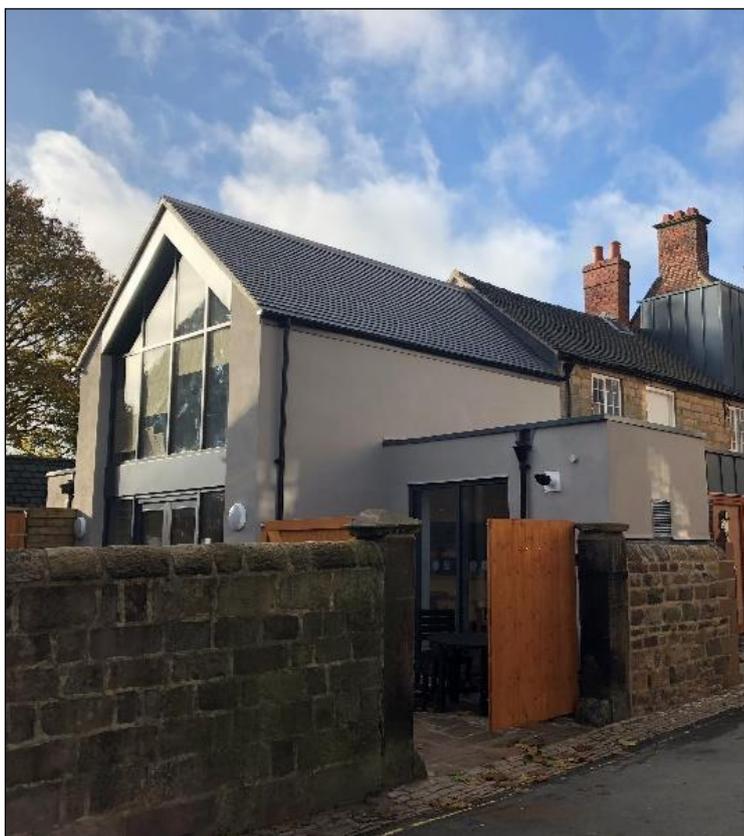
GCA supported the project from the very start, beginning with a structural appraisal of the existing structure, and working through to completion of construction.

We used our engineering experience and expertise to confirm that the existing historic fabric was structurally adequate, avoiding the carbon footprint of reconstruction even where they were not compliant with modern codes.

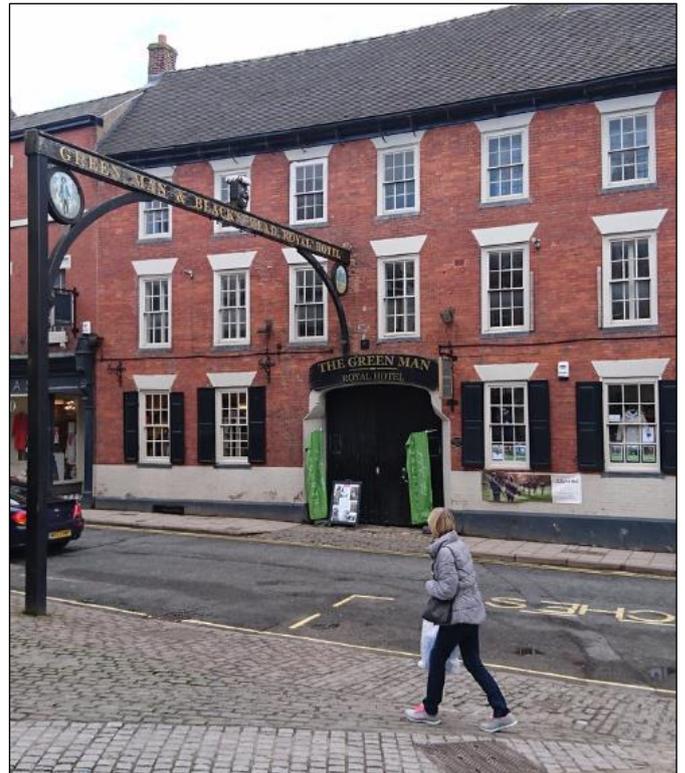
## The Green Man Hotel, Ashbourne

The project required the sensitive conversion of 18<sup>th</sup> century structures, as well as new contemporary buildings on the site.

Through a number of phases, GCA developed practical solutions to conservation engineering challenges, resulting in cost-effective engineering works that enabled significant redevelopment and remodelling of a complex group of buildings around a central courtyard.

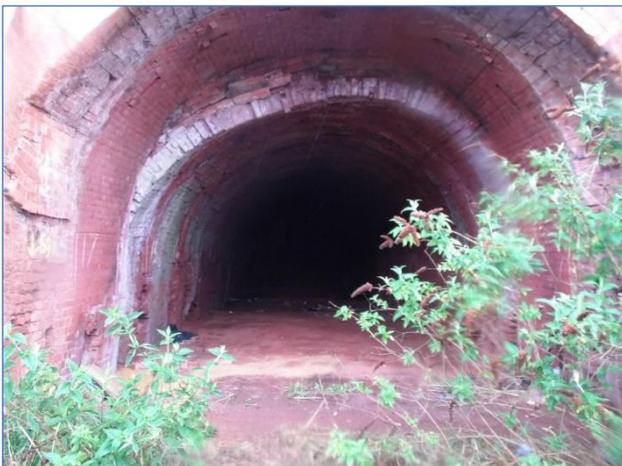
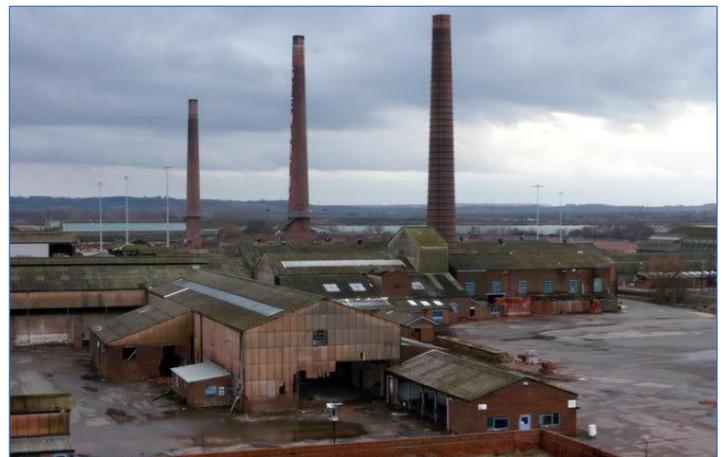
## Stewartby Brickworks

Between 2018 and 2021, GCA were requested to carry out an independent structural assessment of a group of listed chimneys as Stewartby Brickworks.

Our role was to assess supporting evidence relating to an Application for Listed Building Consent for demolition of the four listed chimneys.

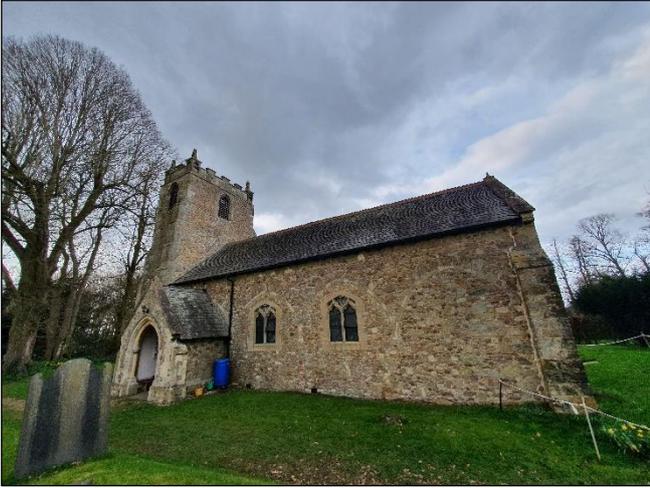
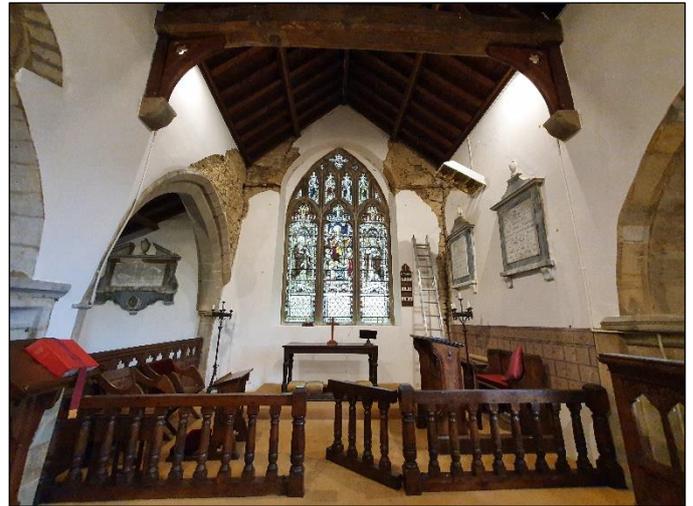
The East gable was leaning excessively with (at the onset of our appointment), no clear cause. Our brief was to advise all parties on the present condition.

GCA identified the most likely cause of movement, proposed appropriate remedial works and then supervised the installation of remedial ties.

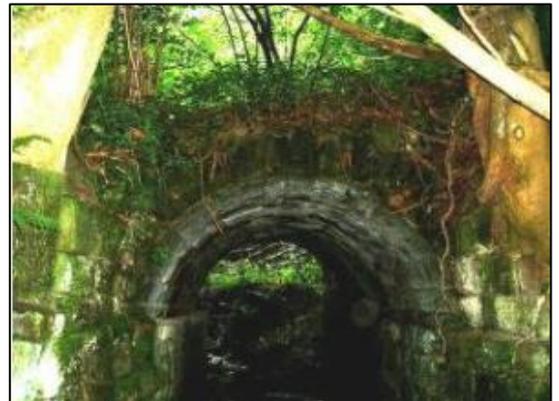
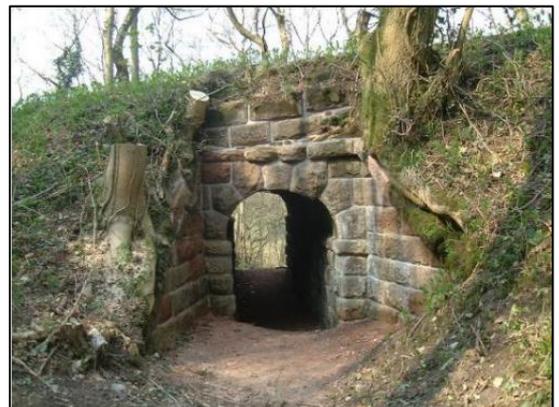
GCA were invited to undertake a geometrical and condition survey of the two aged stone masonry bridges, to make appropriate recommendations for their sensitive conservation repair.

The client had previously identified that part of these structures appeared unsafe, but the structural appraisal confirmed there was no immediate danger of catastrophic failure or risk of collapse. GCA were asked to prepare a sympathetic but urgent repair scheme to make the structures safe and avert any danger to the public who may come across them.

During the repair works new stone was sourced from local quarries, transportation of which had to be considered due to the location and terrain of the site.
